Back Analysis of a Rockfall Event and Remedial Measures along Part of a Mountainous Road, Western Saudi Arabia

Bahaaeldin Sadagah

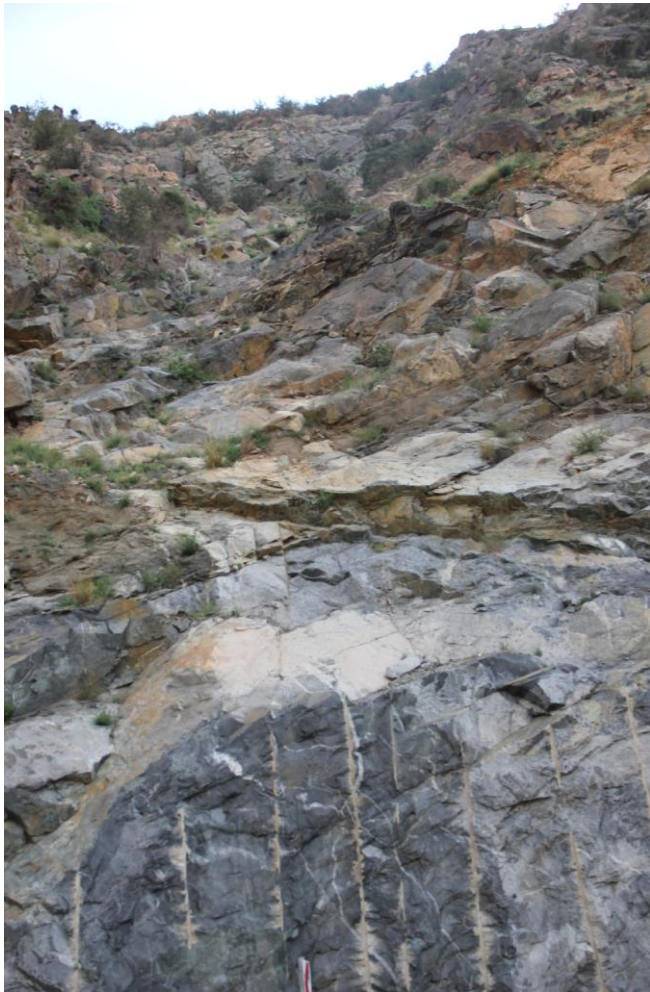
The rock's masses geotechnical properties as encountered in the study specific site (Fig. 4) are as follows: blocky, rigid, slightly weathered [14]. The average rock blocks sizes about 0.6 m³. However, sizes of some fallen hanging rocks are greater, as seen on the road,

and inferred from the indent's sizes on the pavement. Such huge rock blocks are dropping from remote higher elevations; reach up to about 110 meters above the road elevation, as estimated from the damage it caused to the light columns along the road centerline (Fig. 5), and hitting a car on the ascending road (Fig. 6).

Fig. 4. Both man-made and natural rock slope at the study site, source of seeder points of rockfalls

The overall rock masses RMR rating calculated as follows: 1) Strength of intact rock material = 12, 2) RQD = 20, 3) Spacing of discontinuities = 16, 4) Condition of discontinuity = 15 and 5) groundwater condition = 13, then the RMR₈₉ = 76, classified as good rock before adjustment. According to the

attitudes of the prevailing joints at this specific station, the favorability of the joint sets decreased the RMR rating to RMR₈₉ = 51 after adjustment, where rock mass class rating is (III), classified as fair rock.

The quality of the joint distribution in the rock mass and the man-made slope cut orientation decreased the rating of the rock mass from good to fair class.

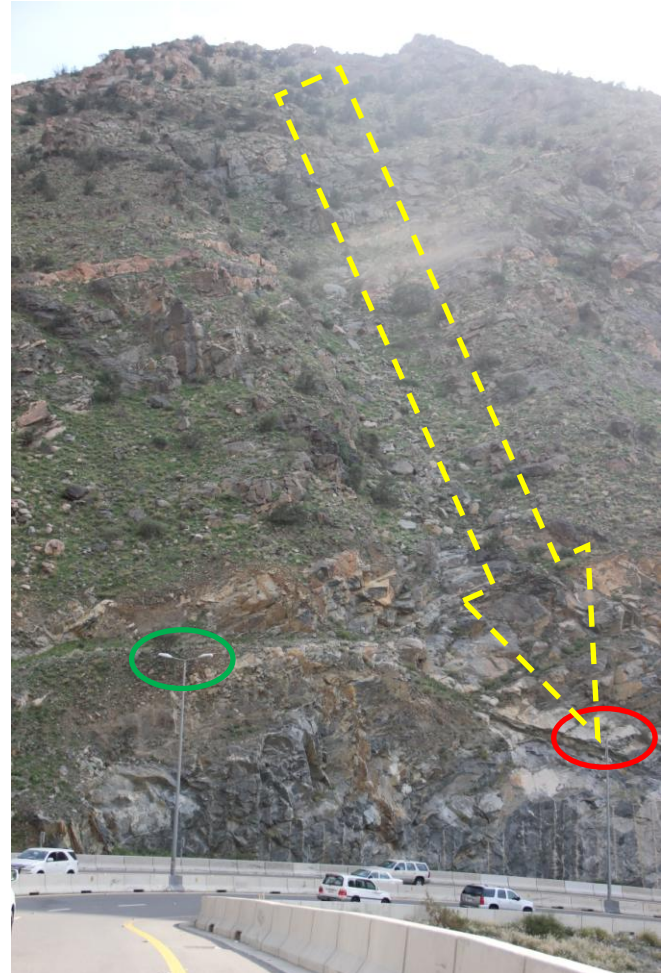
Fig. 5. The broken light lamp due to rockfall (red). The trajectory shown in yellow, while the safe light lamp shown in green

Many rockfall incidents encountered along the road and studied separately [3], [24] and [25]. The slope in concern is unsupported against either rock slope instability (Fig. 4) or rockfall (Fig. 5) incidents. Therefore, after the rainfall event a rock block fall from higher elevation and break the lamp of the post at the road centerline (Fig. 5), and hit a car at the middle of the ascending road (Fig. 6). Utilizing the damage on the road and using the trial and error method, back analysis of the seeder points of rock blocks were modeled using the RocFall program v6 [26]. Figure 9 show the way light lamp damaged due to the jump of the rock block as it falls on the asphalt surface and hit the lamp of 12 m above the asphalt surface.

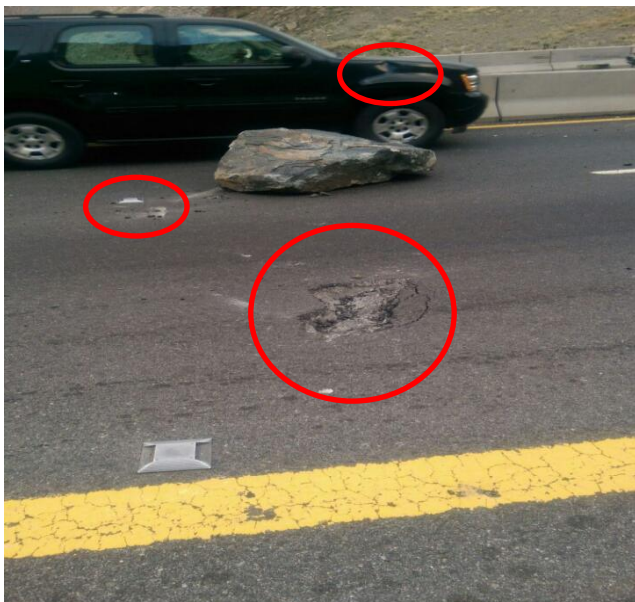
Fig. 6. A fallen rock block hit a car in the ascending road

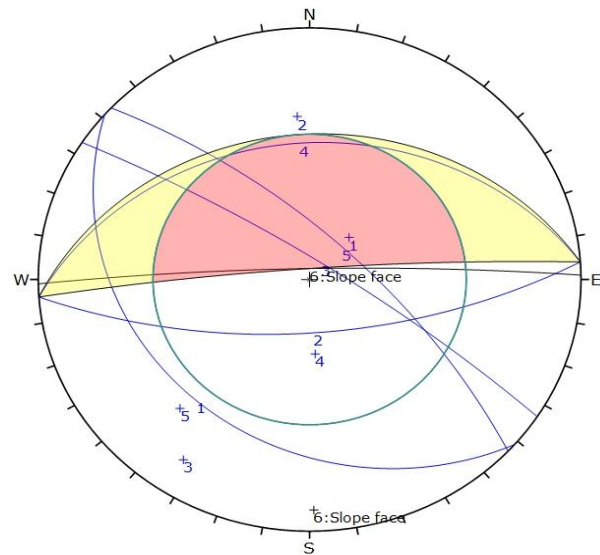
A 100 joint attitude's readings collected at the study site. The joint's distribution indicates the presence of five joint set's attitudes of a wide scatter of the low concentration joint sets (Fig. 7). The computer program DIPS v.6 [18] used to draw the stereographic projection of the present joint's sets applying the kinematic graphical technique [19] and [20] used to analyze the stability of the site.

Fig. 7. Rock slope stereonet

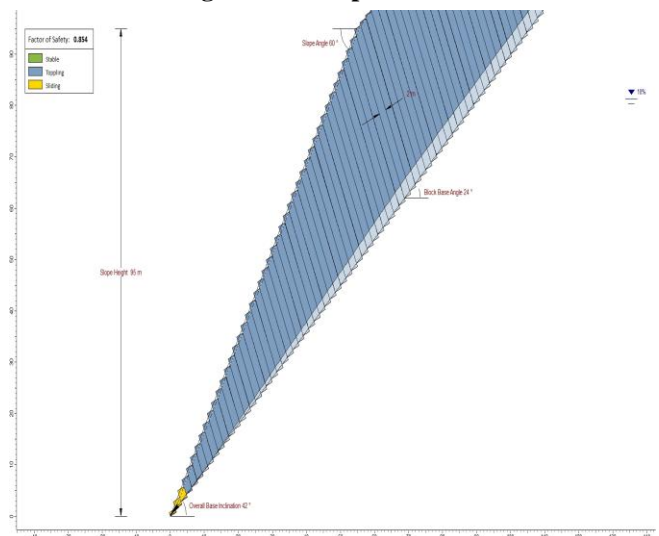
This stability analysis shows the presence of 1) planer failure along joint set # 4 where the factor of safety is <1; 2) no wedge failure, and 3) flexural toppling failures along joint sets # 2 where the factor of safety is 0.85 (Fig 8). At dry condition the factor of safety is <1, and naturally; it is <1 in rainy times [3].

Fig. 8. Toppling failure at the study site

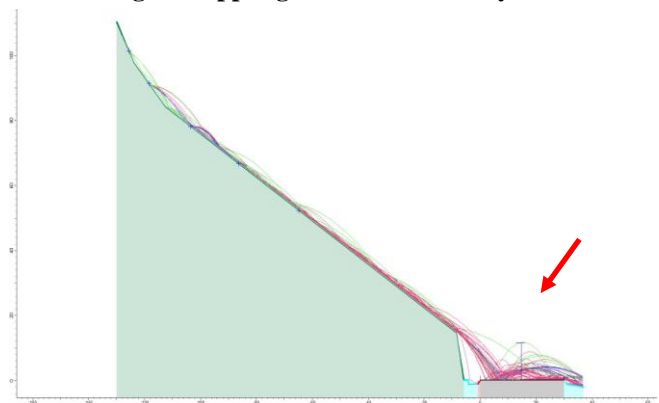
Fig. 9. Rockfall trajectories over the road break the road lamp of 12 m height shown by red arrow

The fallen rock blocks are emerging from five possible point seeders. The location of the seeders s determined during field investigations (Fig. 9). The bounce height could reach up to 16 m either directly rebounding from the rock mass or after rebound from the asphalt surface which could hit all the road and reach behind the far New Jersey (Figs. 10 and 11).

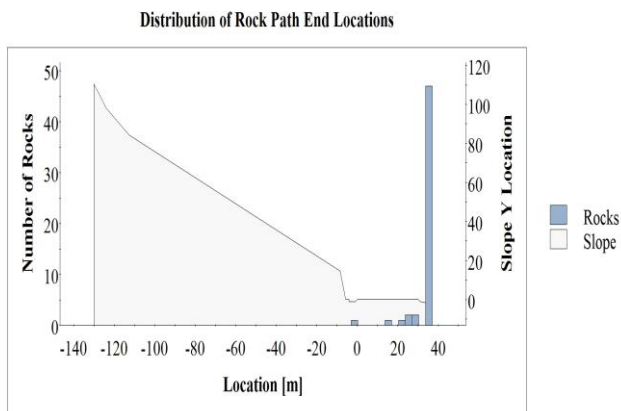
Fig. 10. End point of the fallen rock blocks

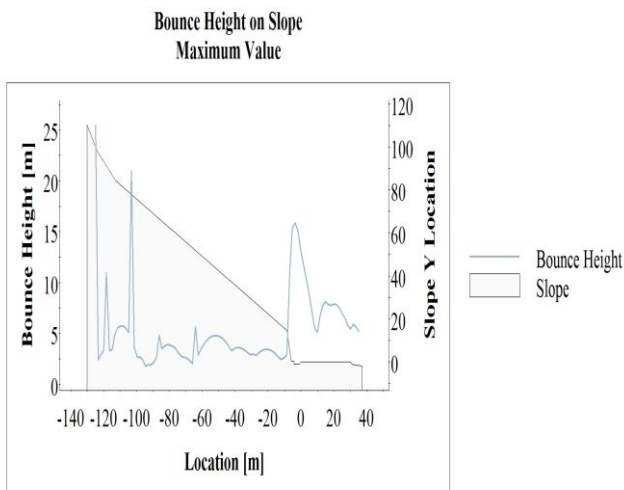
Fig. 11. Bounce height of the rockfalls

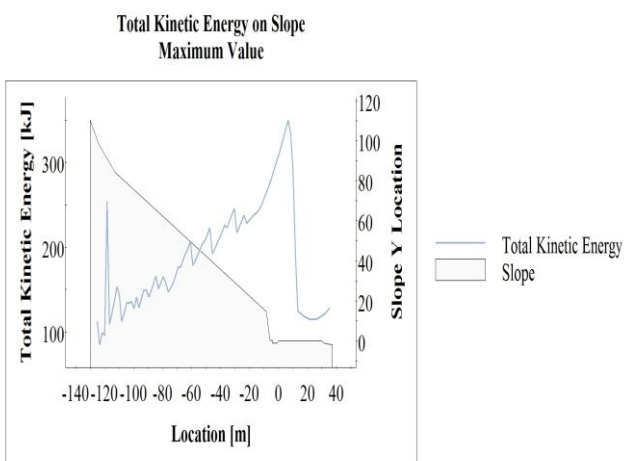
The total, translational and rotational kinetic energies result from the fallen rocks show that the translational kinetic energy is much larger than the rotational kinetic energy (Figs. 12, 13, and 14) which indicated the jumping behavior of the rockfall over the high natural slope angle. Whereas, the translational is much larger than the rotational velocity (Figs. 15 and 16).

Fig. 12. Total kinetic energy of the rockfall

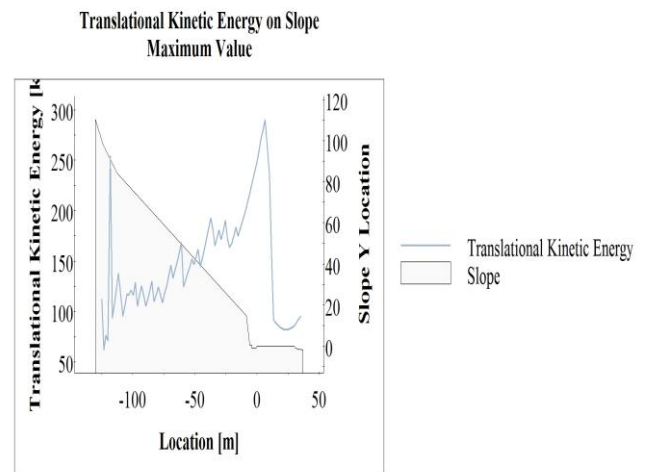
Fig. 13. Translational kinetic energy of the rockfall

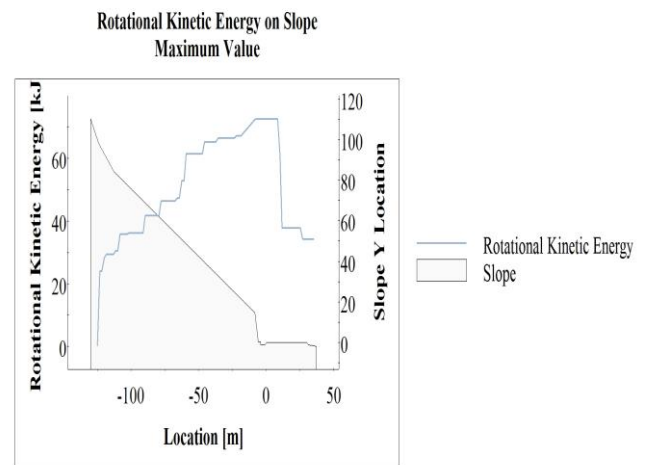
Fig. 14. Rotational kinetic energy of the rockfall

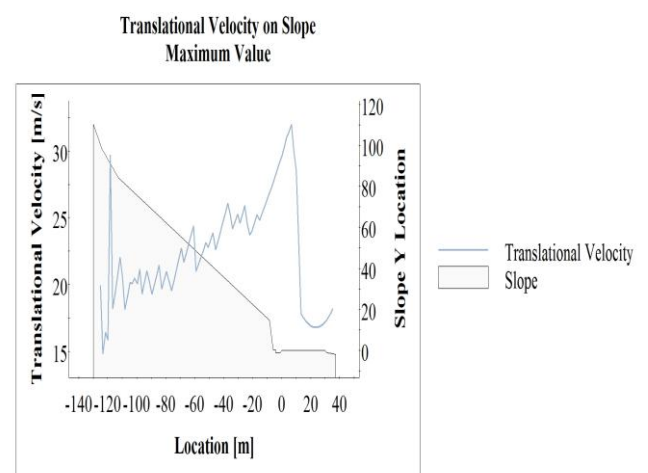
Fig. 15. Translational velocity of the rockfall

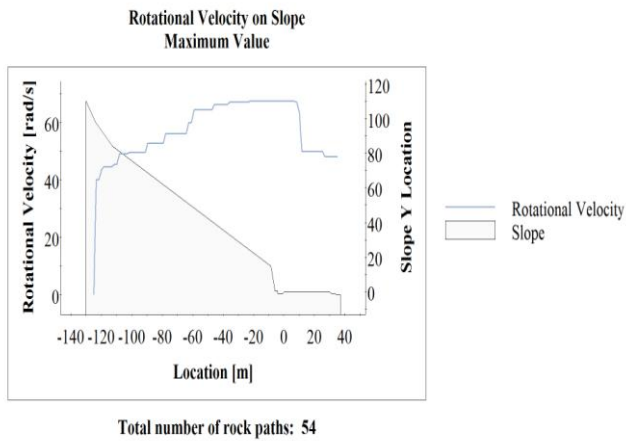
Fig. 16. Rotational velocity of the rockfall

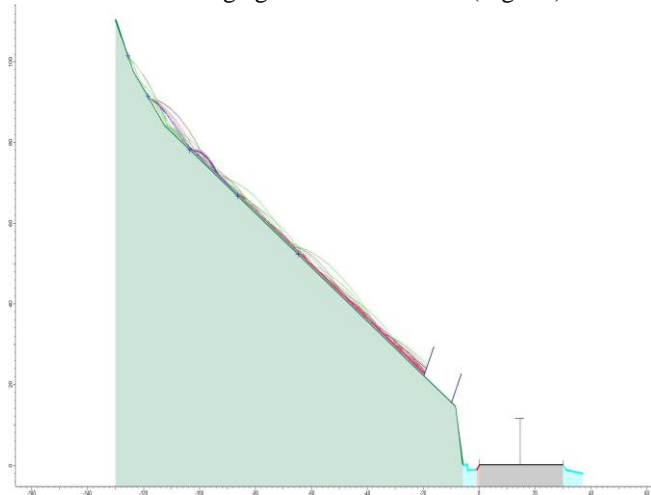
Fig. 17. Locations of rockfall barriers

This rockfall incident damage provoke a quick study to control this problem at this site. Modeling process of the show that it is necessary to place two rockfall barriers of strength 8500 kJ of 8 m height and 30 m length along the valley to stop the rocks from falling again at this location (Fig. 17).

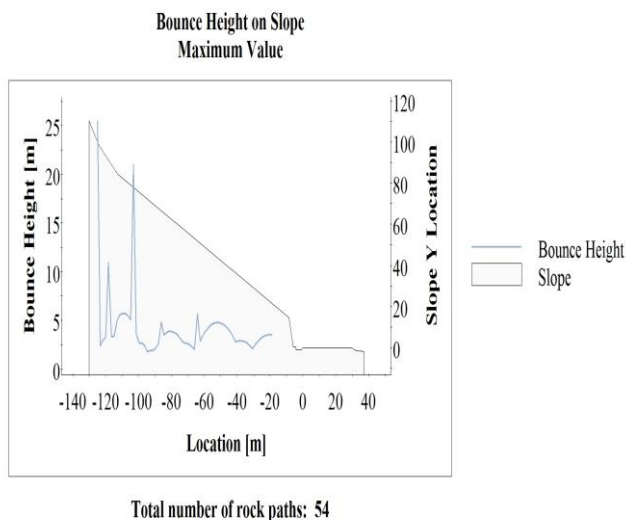
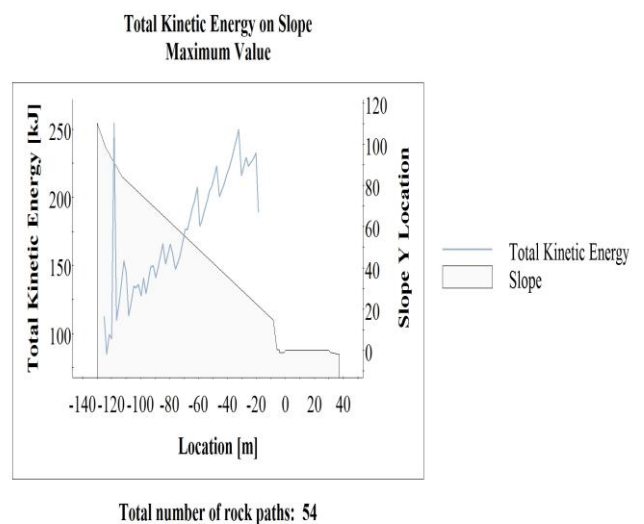
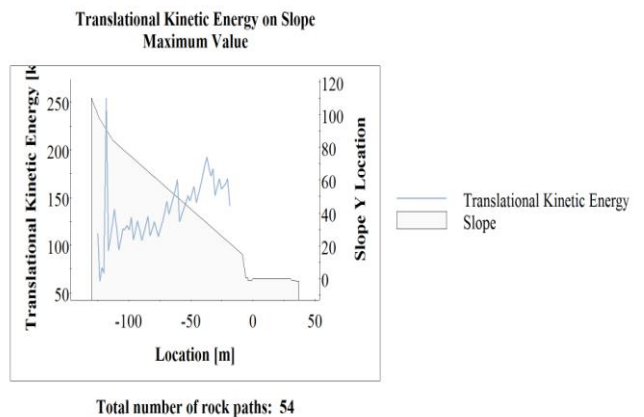
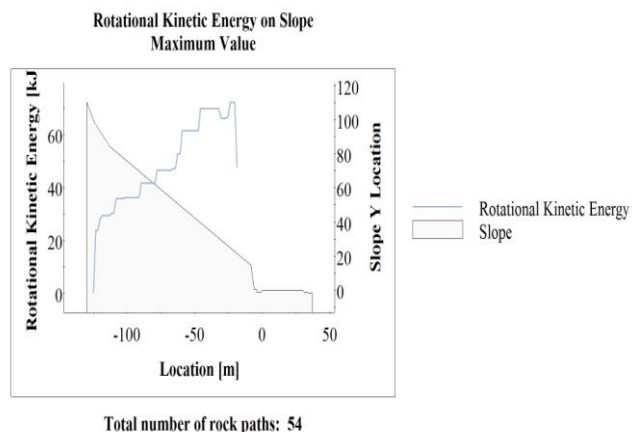
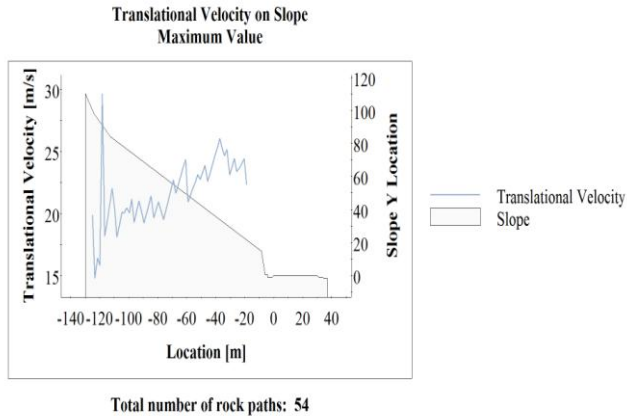
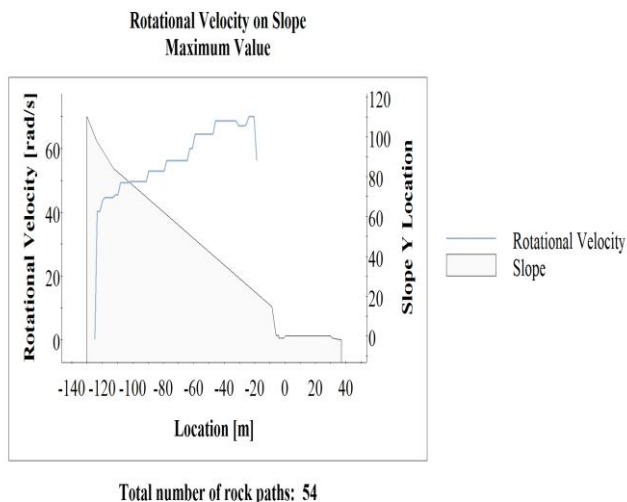
The placement of the barriers highly reduced the bounce height, kinetic energies and velocities along the gully and the natural rock slope (Figs. 18 to 23).
