Remedial Measures against Combined Debris Flows and Rockfalls Hazards along Part of a Mountainous Road, Western Saudi Arabia

Bahaaeldin Sadagah

Index Terms—Al-Hada road, rockfalls, debris flows, rainfalls.

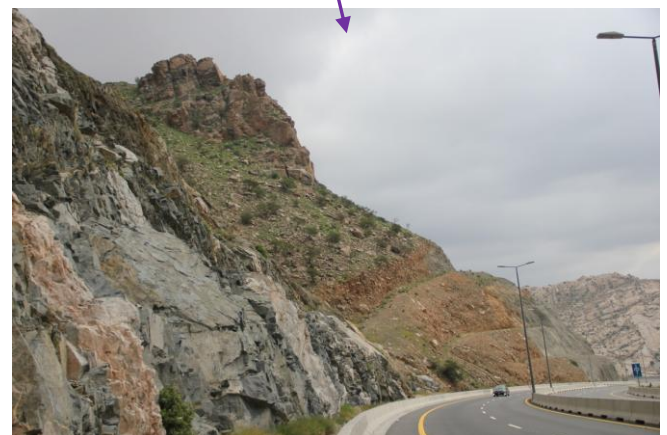
Al-Hada descent area lies west of Al-Taif city, below the edge of the plateau. It includes two distinct geomorphologic terrains: 1) a dissected upper plateau formed of low hills and mountains, and 2) a severe escarpment cliff extends north south. The study area, as a whole, characterized by rugged and steep terrain with steeply structurally controlled gully, and narrow crested ridges sub catchment area originated as a part of a large catchment area. Al-Hada road intersects a number of catchment areas. The most prominent of these rugged terrains is the northwesterly trending Asir or Tihama escarpment, a traceable structure for some 1,500 km, extends parallel to the Red Sea coast. The descent road alignment at the upper part intersected by 14 very steep gullies with a slope gradient of almost 45 to 80 degrees, where it reaches the lowest and highest elevations, respectively [6]. More gullies are located, but has a different degrees of hazard to the road [7]. The gully in concern has an inclination angle overall of 45 degrees. The compaction of the accumulations through years of the whole volume of the products, which formed because of rock slope failures, rockfalls and previous debris flows incidents, in addition to the falling fine materials from higher elevations and in-situ weathered materials. All these materials formed a mixture of compacted debris of well-graded materials (Figs. 3 and 4). The nearest fresh rock is almost 50 m height where the inclination angle decrease at lower elevation and increase close to the mountain top. The highest and lowest elevation of the gully are 1470 m and 1390 m, making an elevation difference of more than 80 m. The site formed of three man-made inclined terraced berms through the debris underlain by the weathered rock masses.

Fig. 4. An inclined slope berm cut formed of the debris accumulation.

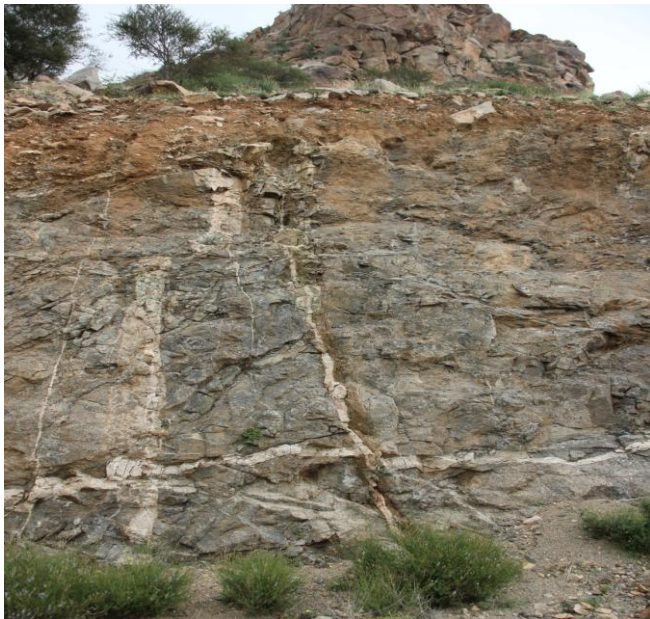
The rock mass rating (*RMR*) [10] is one of the several system available to characterize any rock mass, has a worldwide acceptance and applications [11]. This acceptance has resulted, in part, from useful design/construction decision tools that are related to an assessment of the *RMR* values of a rock mass, e.g., span width and stand-up time for underground excavations—the initial application of *RMR* values; excavated slope design [12], ground supports requirements [13], ease of excavation [14]. The rock's masses geotechnical properties as encountered in the study specific site (Fig. 4) are as follows: blocky, rigid, slightly weathered [15]. A wide range of rock blocks are falling, where the average size about 1 m³. However, sizes of some fallen rocks along the failure path are greater, as seen on the ditch, on the debris slope, and inferred from the indent's sizes on the highway. The seeder points of the large fallen rock blocks are dropping from higher elevations; reach up to about 80 meters above the road level, with the absence of remedial measures.

Fig. 4. Man-made and natural rock slope at the study site, where sources of seeder points of rockfalls are numerous.

This stability analysis shows the presence of 1) planer failure along joint set # 5 where the factor of safety is <1; 2) wedge failure took place along the intersection between joints sets # 3&5, 4&5, 1&5, and 1&4, and 3) flexural toppling failures along joint sets # 6 where the factor of safety is <1 (Fig. 5). The used utilized softwares for analyses are *RocPlane* v.3 [22], *Swedge* v. 6 [23], and *RocTopple* v. 1 [24], respectively. At this environment elevation dry condition, the factor of safety is <1, and naturally; it getting worse in rainy times [3], where the falling rock block from higher elevations related to any of the above encountered slope failure modes from high elevation, rest on the natural slope face forming debris accumulation of huge size (Figs. 3 and 4).

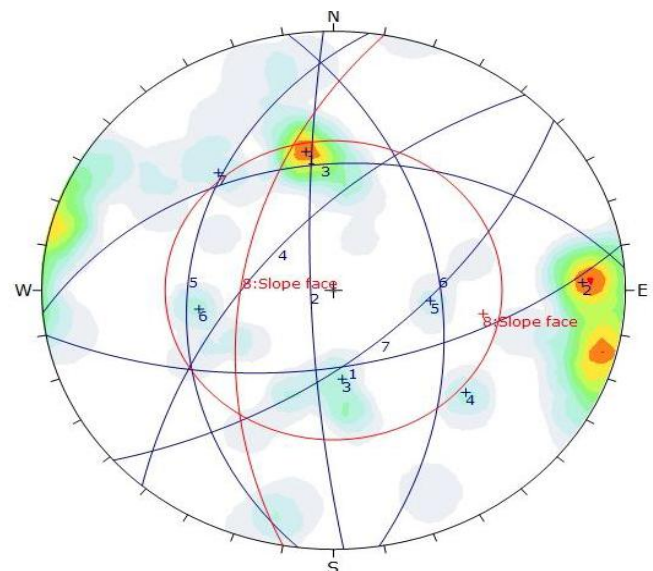
Fig. 5. Stereonet of the prevailing joints sets.

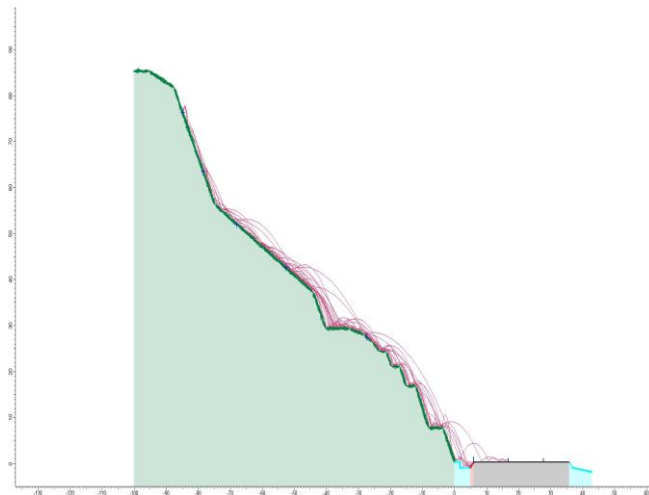
After the rainfall event in 30 Nov. 2014 the water percolates in the joints and debris particles, then increase pore water pressure, decreased the cohesion between the blocks and debris particles. As the driving forces increased and getting greater than the stabilizing forces, then the rock move down the slope in a form of a rockfall, two days after the rain event. Some of the blocks continue its falling path to reach the ditch and the road. While other blocks stay unbalanced on the slope profile forming a loose blocks of variable sizes considered as rockfall seeder points, waiting for suitable conditions (decrease of soil friction angle along the slope, push from another block, earthquake, rainfall) to continue the falling path process down towards the road, forming a more rockfall hazards on the road. Al-Hada road suffers from rockfall incidents encountered along the road and studied separately [3], [25], [26] and [27]. The slope in concern is unsupported against geohazards, such as rockfalls, debris flows and rock slope instability. Therefore, after the rainfall event a rock block fall from higher elevation and damage the road pavement. Utilizing the damage on the road and using the trial and error method, the possible locations of the seeder points of rock blocks, as observed from the field study (Fig. 6), were defined and modeled using the *RocFall* program v6 [28].

Fig. 6. Rockfall trajectories along the study site.

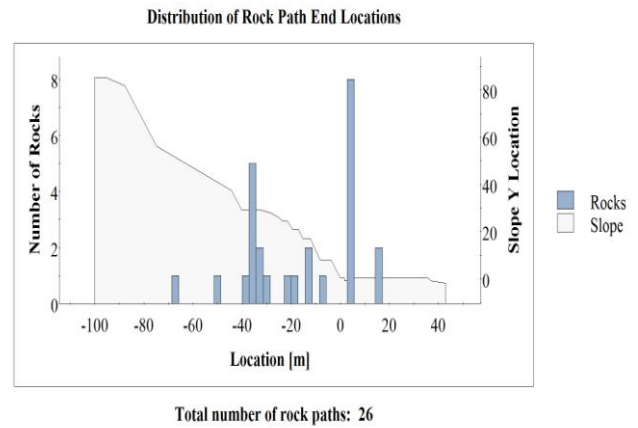
The fallen rock blocks are emerging from six possible point seeders. The end point and bounce height could reach up to 6-8 m on the road surface (Figs. 7 and 8). The total kinetic energy, translational velocity given (Figs. 9 and 10). This rockfall incident damage provoke a quick study to control this problem at this site. Modeling process show that it is necessary to place three inclined rockfall barriers of strength 8500 kJ of 8 m height and 30 m length along the berm to stop the rocks from falling again at this location (Fig. 11).

Fig. 7. End point of the fallen rock blocks.

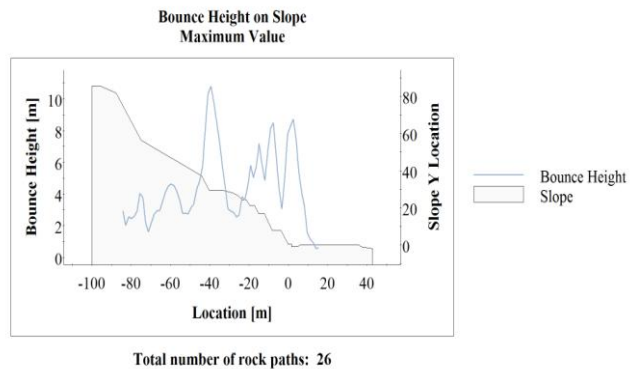
Fig. 8. Bounce height of the rockfalls.

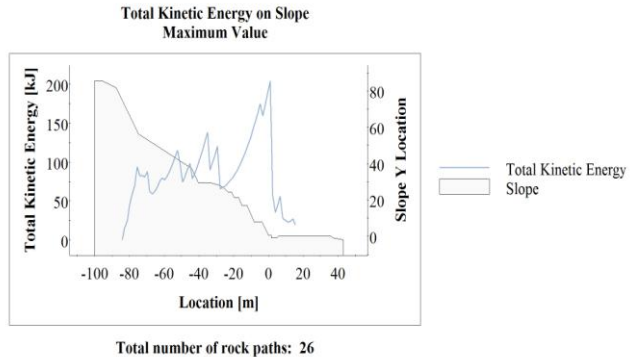
Fig. 9. Total kinetic energy of the rockfall.

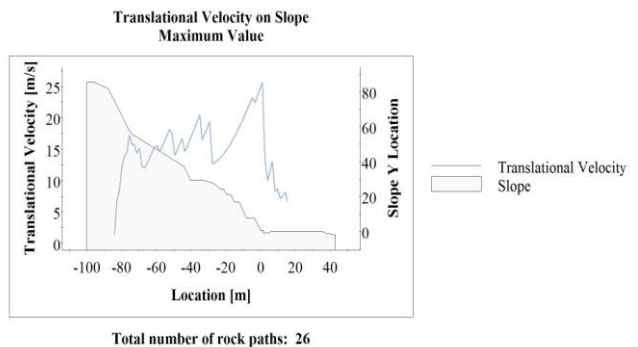
Fig. 10. Translational velocity of the rockfall.

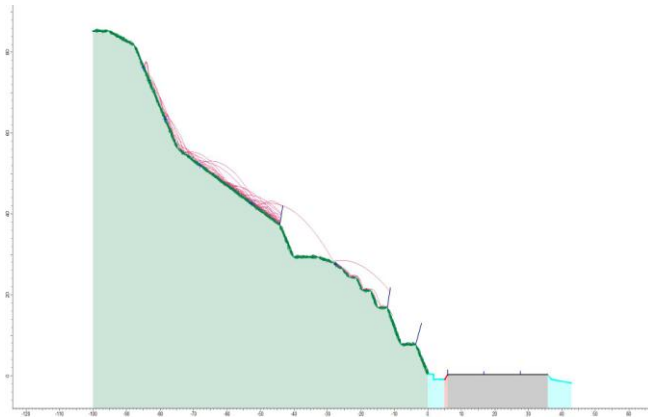
Fig. 11. Locations of rockfall barriers.

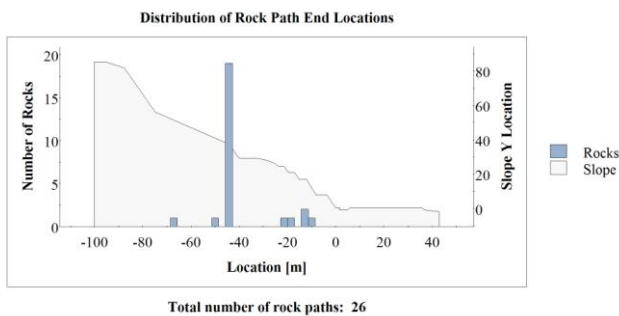
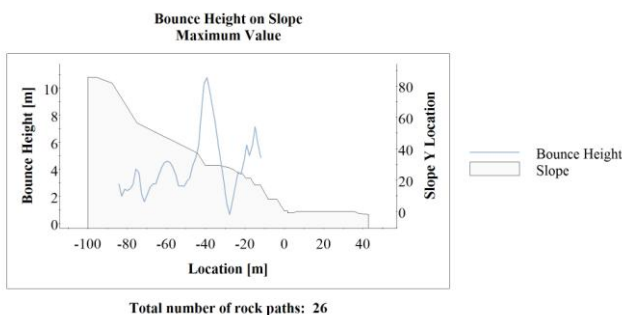
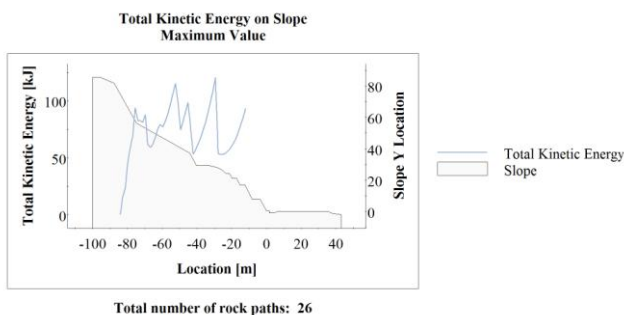
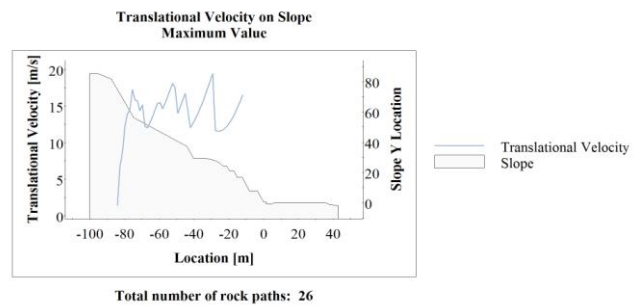
Fig. 12. The end point after installation of rockfall barriers.

Fig. 13. The bounce heights after installation of rockfall barriers.

Fig. 14. Total kinetic energy after installation of rockfall barriers.

Fig. 15. Translational velocity after installation of rockfall barriers.

The placement of the barriers highly reduced the end point, bounce height, kinetic energy and velocity along the natural rock slope (Figs. 12 to 15).

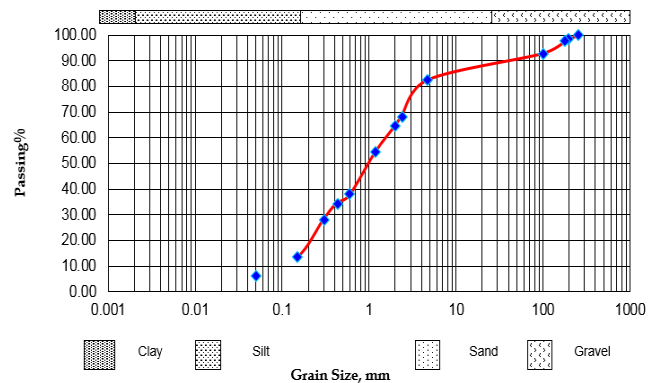
Fig. 16. Grain size analysis of the debris accumulations, excluding large rock blocks more than 10 mm diameter.

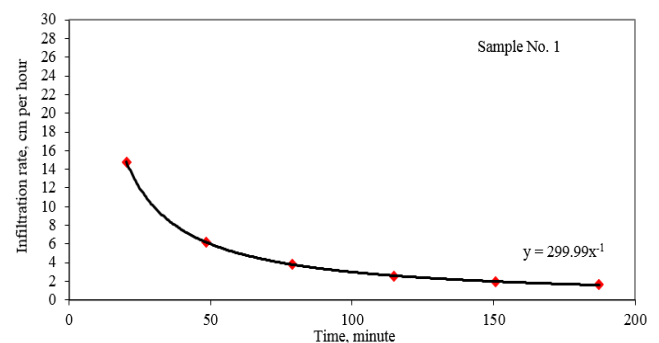
The other mode of geohazard is the debris accumulations, which are located along the gully starting from the higher elevation down to the ditch. In situ measurement of the infiltration rate of the debris shows that it is almost 2.5 cm/hr (Fig. 17). The shear strength of the debris were tested at 0%, 10% 20% water content of the soil. Three samples tested for each water content ratio. The samples tested under three stress levels 100, 200, 300 kPa (Figs. 18, 19, and 20). The results shows a general decrease of the cohesion and friction angle as the water content increase. The maximum and minimum obtained friction angle are 30° and 13°, respectively. As the water content increase in the soil, which is representing the intensity of the rain, the friction angle decrease, which cause a debris flows at this particular debris accumulation at the site.

Fig. 17. The infiltration rate of the debris accumulation at the site.

The remedial measures for this debris at the site is to build a series of check dams across the debris avalanche path, of type sabo/slit barrier [29]. This type is capable to prevent the debris flows blocks to reach the road, where it could pass the water and the fine sediments to pass through the openings and directed towards the culvert.

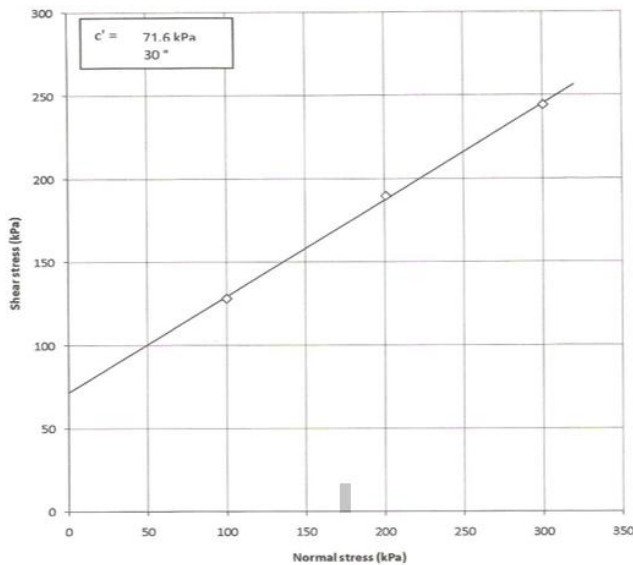
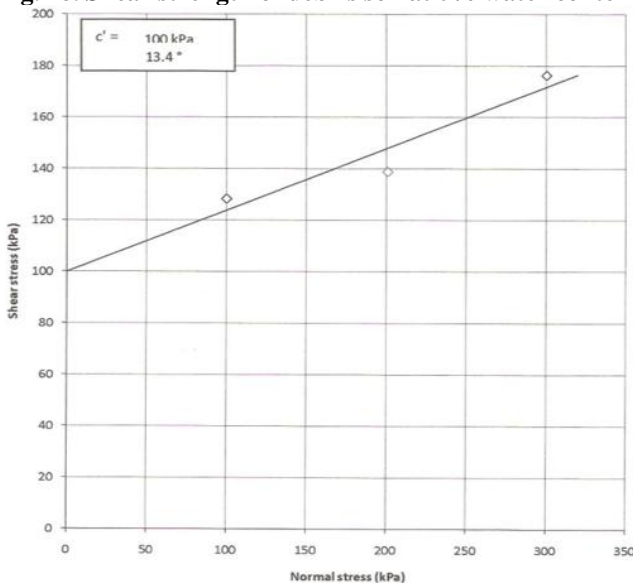
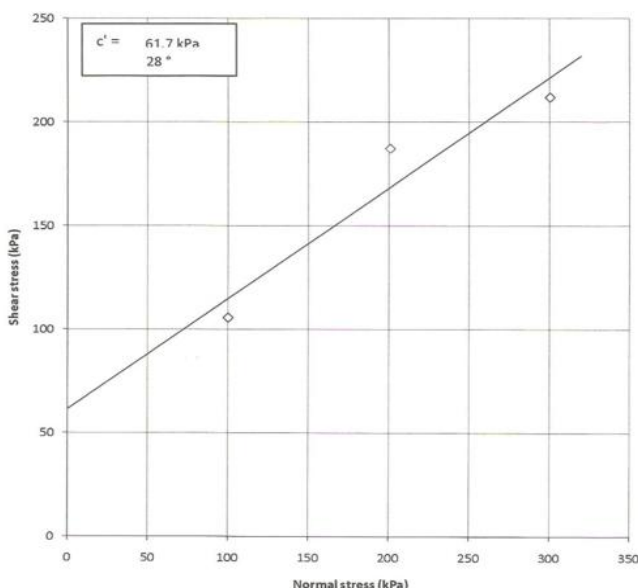
Fig. 18. Shear strength of debris soil at 0% water content.

Fig. 19. Shear strength of debris soil at 10% water content.

Fig. 20. Shear strength of debris soil at 20% water content.
