# Failure and Stresses Develop in Insulated Rail Joints: General Perspective

**Abstract** — Rail joints are used for the purpose of joining the two rails. Due to large number of drawbacks and for safety purpose the number of joint in mainline track has been minimized by the widespread use of continuously welded rail (CWR). For automated block signaling it is required to have sections of track electrically insulated from each other, disallowing the rail to be continuously welded as is done where possible, this joint is called as insulated rail joint (IRJ). The IRJ is however substantially weaker than the rail and so is subjected to large stresses, causing failure. This paper is part of study into various stresses develop in various components of IRJ and future scope in it so that performance of assembly can be improved.

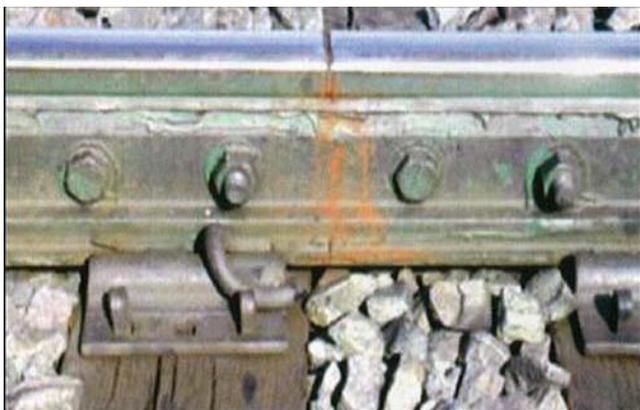
**Fig. 4 Failed Glued Bond in IRJ**

Kerr and Cox [1] carried out an analysis of insulated rail joints subjected to vertical wheel loads. They presented a semi-analytical relationship to illustrate bending moment distribution in the vicinity of joints and central deflections. It was indicated that the bending moment distribution leads to delamination failure due to the large deflections at the joints. The most frequent cause of IJ insulation failure, as documented by the railroads, is adhesive debonding. The weakened adhesive bond allows moisture intrusion causing metal corrosion and adhesive debonding. The higher stiffness of epoxy adhesives, as compared to the rail steel, seems to be responsible for cracks at the end post. In cases where most of the epoxy bond is still intact, shearing action in the bolts and friction at the debonded surfaces has little effect. On the other hand, when the epoxy debonding becomes extensive enough, the relative displacement between bars and rails grows larger. This allows the bars and rails to bear directly on the bolts, concentrating forces at the edges of the bolt holes. It also creates shear stress on the debonded surfaces that exceeds the maximum static friction stress and causes slippage.[4] In addition to bending, thermal, and residual stresses, rail joints are also subjected to dynamic loads due to these discontinuities[5]. A lower difference in elastic modulus can reduce the interface stress magnitude in the rail ends, however, it could adversely result in higher stress in the insulation material, which may lead to its earlier failure [6]. Electrical failure often results when the loose joint experiences contact between metal surfaces on the rails and joint bars or bolts – a result of fretting, deterioration or wear in the insulator, relative component movement, and related processes. [7]. The modes of failure of IRJ's is different for different countries. Metal flow or plastic deformation in the vicinity of IRJ's is a major problem in Australia, whereas delamination, bond failure, broken joint bar, or looseness of the bolts are the various modes of failure in India ,America and other countries. The weakened epoxy IRJ bond allowed moisture entry and larger deflection. A sign of rust is evident near the end post (fig. 4)

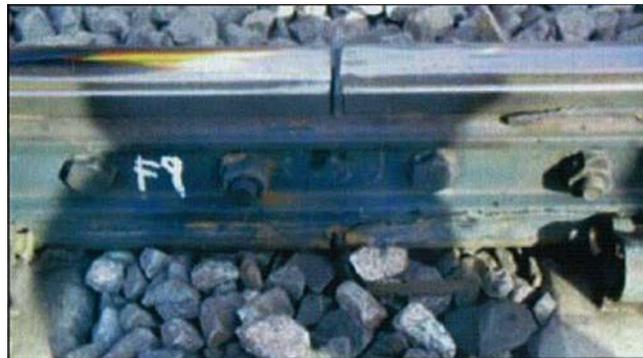
**Fig. 5 End Post Crushed in IRJ Due to Pull-Apart**

The wheel/rail contact impact and the associated longitudinal stress due to wheel loads and perhaps also to thermal effects contributed to bolt looseness. As a result, breaking of joint bar bolts (due to bending), battered end post (fig. 5) and broken joint bar (fig. 6) failures might occur.

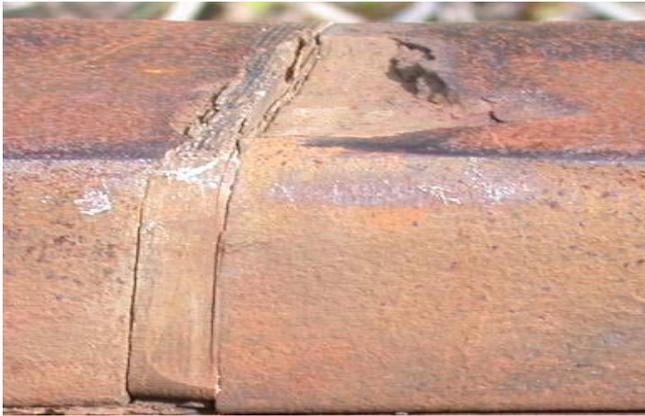
**Fig. 8 A Typical IRJ Failure (Chipping Out)**

Railhead surface defects due to metal plasticity (metal flow) in the vicinity of the IRJ is another type of failure mode. Initiation of this failure mode depends on the presence of running surface defects on the railhead (fig.6) . It can progress to railhead metal failure such as squashing (fig.7) and chipping out. (fig.8).
