Back Analysis of a Rockfall Event and Remedial Measures along Part of a Mountainous Road, Western Saudi Arabia

Bahaaeldin Sadagah

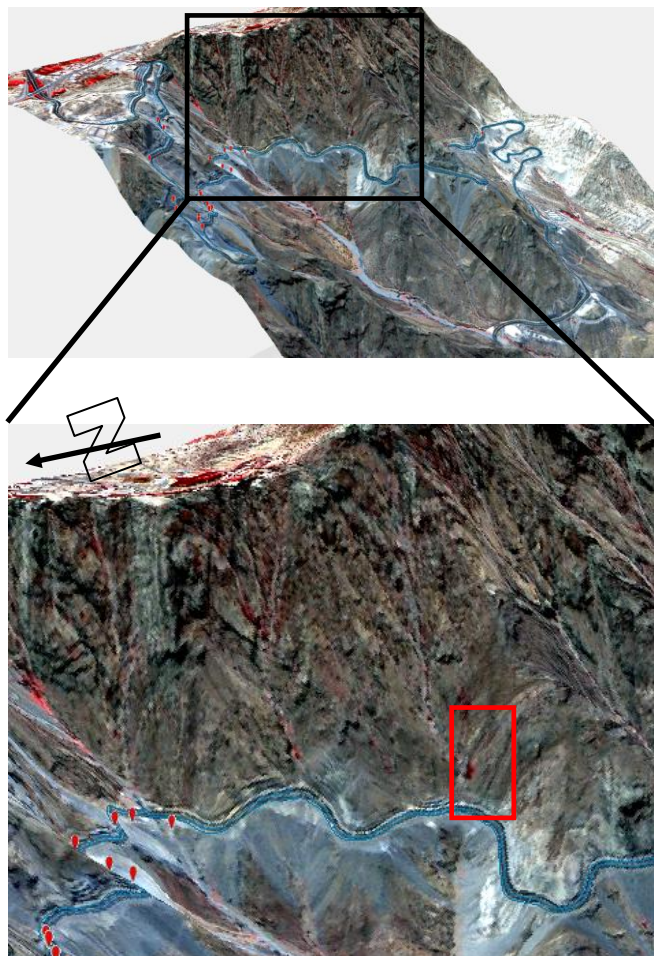
Fig. 3. Geomorphological terrain and enlarged study site

The descent road alignment at the upper part intersected by 14 very steep gullies with a slope gradient of almost 45 to 80 degrees, where it reaches the lowest and highest elevations, respectively [6]. More gullies are located, but has a different degrees of hazard to the road [7]. The gully in concern has an inclination angle overall of 42 degrees. The inclination angle decrease at lower elevation and increase close to 85 degrees close to the mountain top (Fig. 3). The highest and lowest elevation of the gully are 1672 m and 1560 m, making an elevation difference of almost 110 m. The site include gully contain debris accumulations from the fallen rock blocks due to slope failure, rockfalls from both sides of the gully and higher elevation.
