Remedial Measures against Combined Debris Flows and Rockfalls Hazards along Part of a Mountainous Road, Western Saudi Arabia

Bahaaeldin Sadagah

Index Terms—Al-Hada road, rockfalls, debris flows, rainfalls.

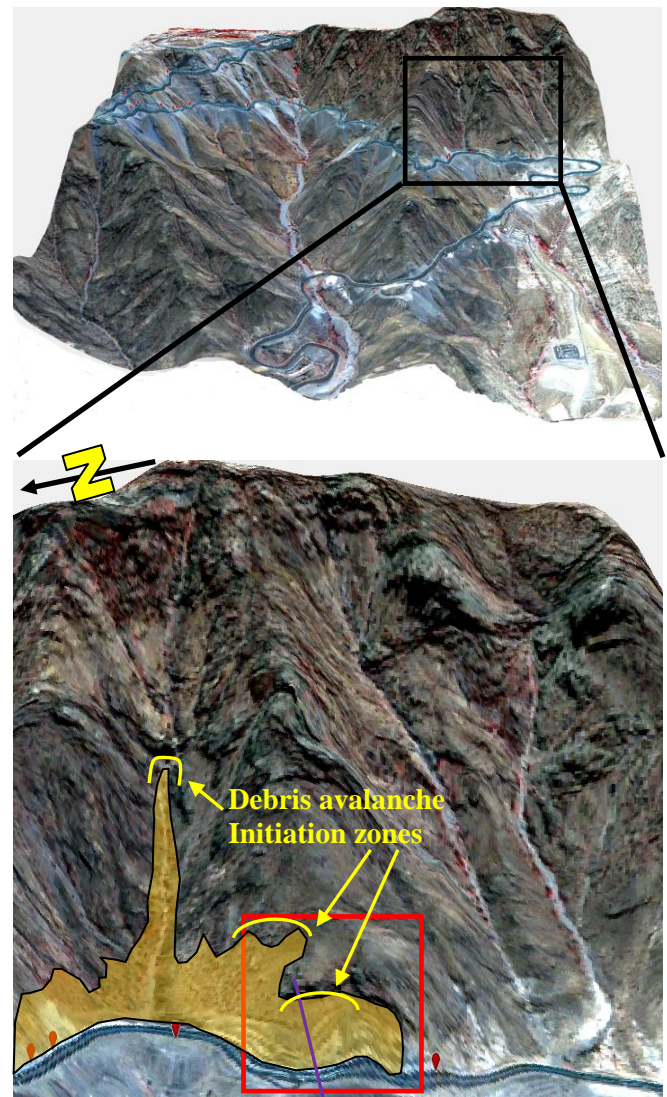
Fig. 3. Geomorphological terrain and enlarged study site.

Al-Hada descent area lies west of Al-Taif city, below the edge of the plateau. It includes two distinct geomorphologic terrains: 1) a dissected upper plateau formed of low hills and mountains, and 2) a severe escarpment cliff extends north south. The study area, as a whole, characterized by rugged and steep terrain with steeply structurally controlled gully, and narrow crested ridges sub catchment area originated as a part of a large catchment area. Al-Hada road intersects a number of catchment areas. The most prominent of these rugged terrains is the northwesterly trending Asir or Tihama escarpment, a traceable structure for some 1,500 km, extends parallel to the Red Sea coast. The descent road alignment at the upper part intersected by 14 very steep gullies with a slope gradient of almost 45 to 80 degrees, where it reaches the lowest and highest elevations, respectively [6]. More gullies are located, but has a different degrees of hazard to the road [7]. The gully in concern has an inclination angle overall of 45 degrees. The compaction of the accumulations through years of the whole volume of the products, which formed because of rock slope failures, rockfalls and previous debris flows incidents, in addition to the falling fine materials from higher elevations and in-situ weathered materials. All these materials formed a mixture of compacted debris of well-graded materials (Figs. 3 and 4). The nearest fresh rock is almost 50 m height where the inclination angle decrease at lower elevation and increase close to the mountain top. The highest and lowest elevation of the gully are 1470 m and 1390 m, making an elevation difference of more than 80 m. The site formed of three man-made inclined terraced berms through the debris underlain by the weathered rock masses.

This stability analysis shows the presence of 1) planer failure along joint set # 5 where the factor of safety is <1; 2) wedge failure took place along the intersection between joints sets # 3&5, 4&5, 1&5, and 1&4, and 3) flexural toppling failures along joint sets # 6 where the factor of safety is <1 (Fig. 5). The used utilized softwares for analyses are *RocPlane* v.3 [22], *Swedge* v. 6 [23], and *RocTopple* v. 1 [24], respectively. At this environment elevation dry condition, the factor of safety is <1, and naturally; it getting worse in rainy times [3], where the falling rock block from higher elevations related to any of the above encountered slope failure modes from high elevation, rest on the natural slope face forming debris accumulation of huge size (Figs. 3 and 4).
